# Topaz™

## Troubleshooting and Software Revision History

P/N 460911001E • 09FEB12

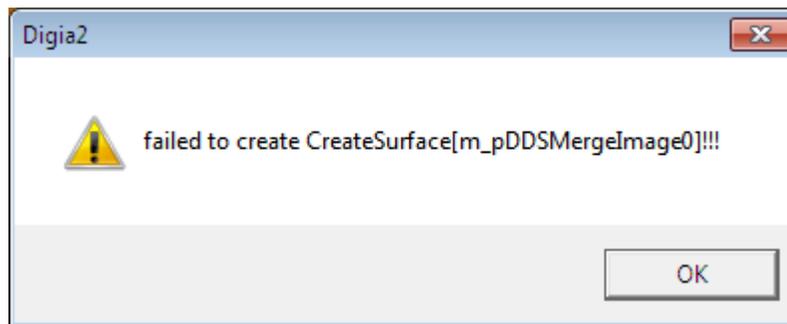
**I have the following warning dialog when launching the user interface.**

Digia2 requires hardware graphics acceleration. This dialog appears when the graphics/video drivers of the PC are not properly installed. These drivers must be properly installed before installing Topaz. These drivers should be available with the CD supplied with the PC.
