# TECHNICAL NOTE

## TruPortal 1.5 Upgrade Troubleshooting Guide

Release Date: 11/27/2013

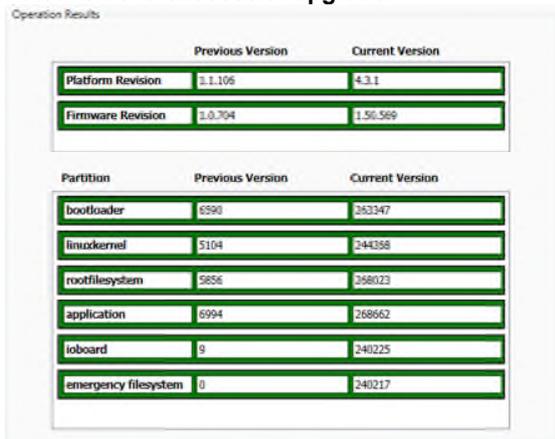
#### Indication of a successful upgrade:

Previous Version	Current Version
Platform Revision	3.1.106	4.3.1
Firmware Revision	1.0.704	1.50.569

Partition	Previous Version	Current Version
bootloader	6398	263347
linuxkernel	5104	244398
rootfilesystem	5656	268023
application	6994	268662
ioboard	9	240225
emergency filesystem	0	240217

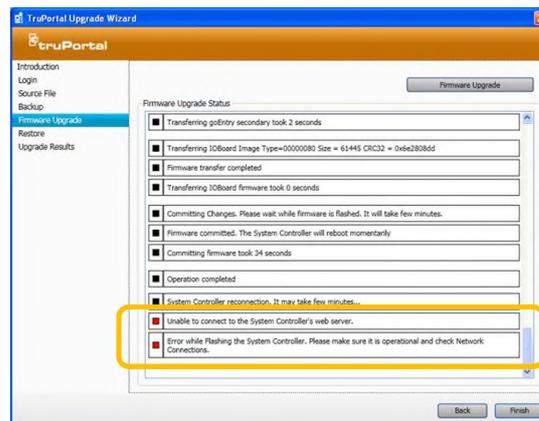
#### Signs of an unsuccessful upgrade (example):

After an unsuccessful upgrade, one or more of the following symptoms are typically observed:

- The System Controller can no longer be reached via its original static IP address that was configured on LAN Port #1, or via the built-in IP address of 169.254.1.200 via LAN Port #1 or #2.
- The System Controller does respond to “ping” and to <http://ip-address> or <https://ip-address> requests, but the web page displayed in the browser is not the expected TruPortal user interface.

Recovery from unsuccessful upgrades is possible and involves the following steps. Note: these steps are not a substitute for using the new Panel Upgrade Wizard. The steps are not effective on systems where the Upgrade Wizard has never been used. **Please read the detailed instructions before proceeding. If you are not comfortable with carrying out the detailed steps, please contact Technical Support for assistance.**
